# Marina Gate 2 — Apt 2408

Snagging report · 6 Aug 2026, 09:41

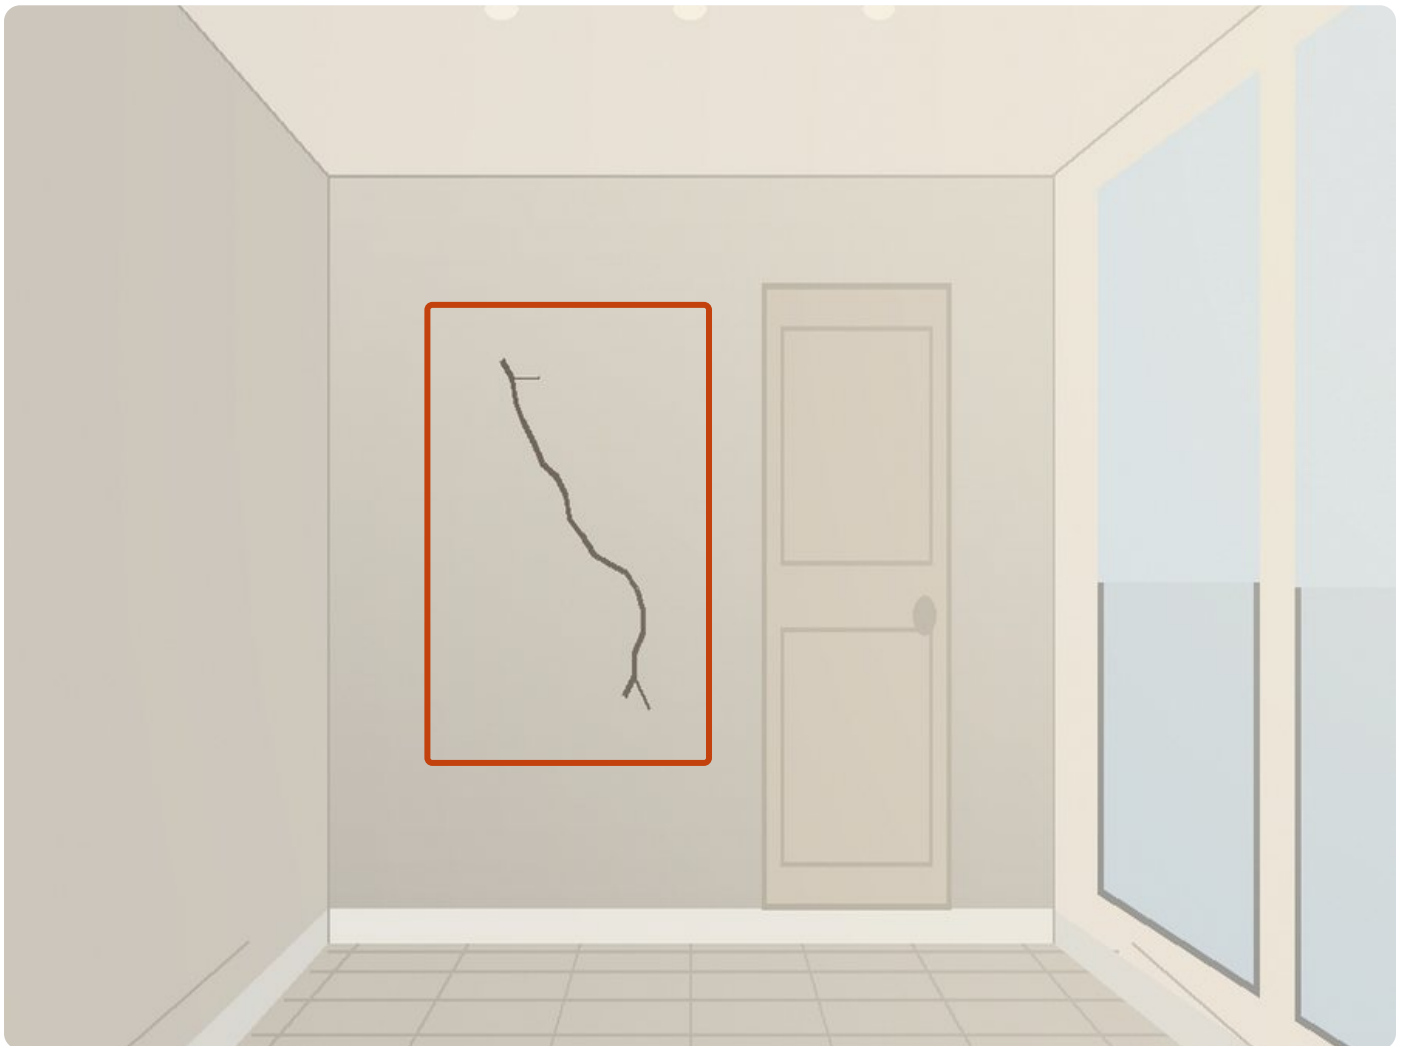
Living room

## Diagonal crack at window reveal

**MAJOR**

A hairline-to-2mm crack runs diagonally from the upper corner of the window reveal across the plaster. Crack is continuous rather than a paint-only hairline, suggesting movement or inadequate bead fixing.

**Recommended action:** Rake out, fit mesh reinforcement over the reveal corner, re-skim and re-paint the full wall to avoid a patch line.

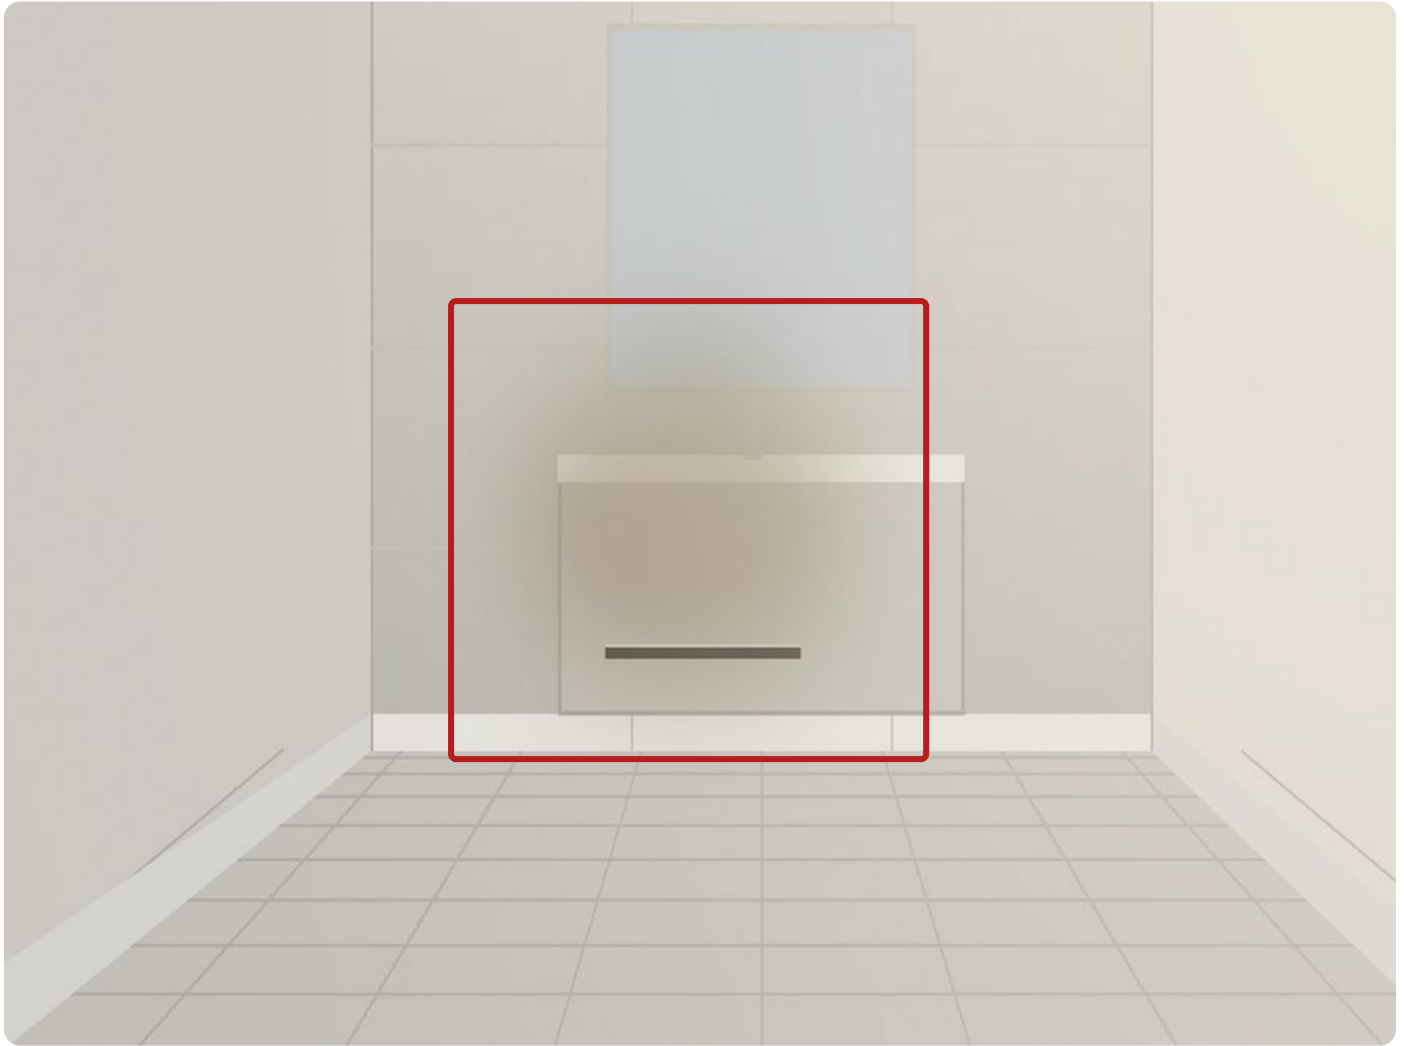
Bathroom 1

## Water staining under vanity unit

CRITICAL

Dark tide-marked staining on the vanity carcass and adjacent tile grout, consistent with an ongoing leak at the trap or supply connection rather than a historic spill.

**Recommended action:** Isolate supply, pressure-test the trap and flexible connectors, replace failed seals, dry out and replace the affected carcass panel.

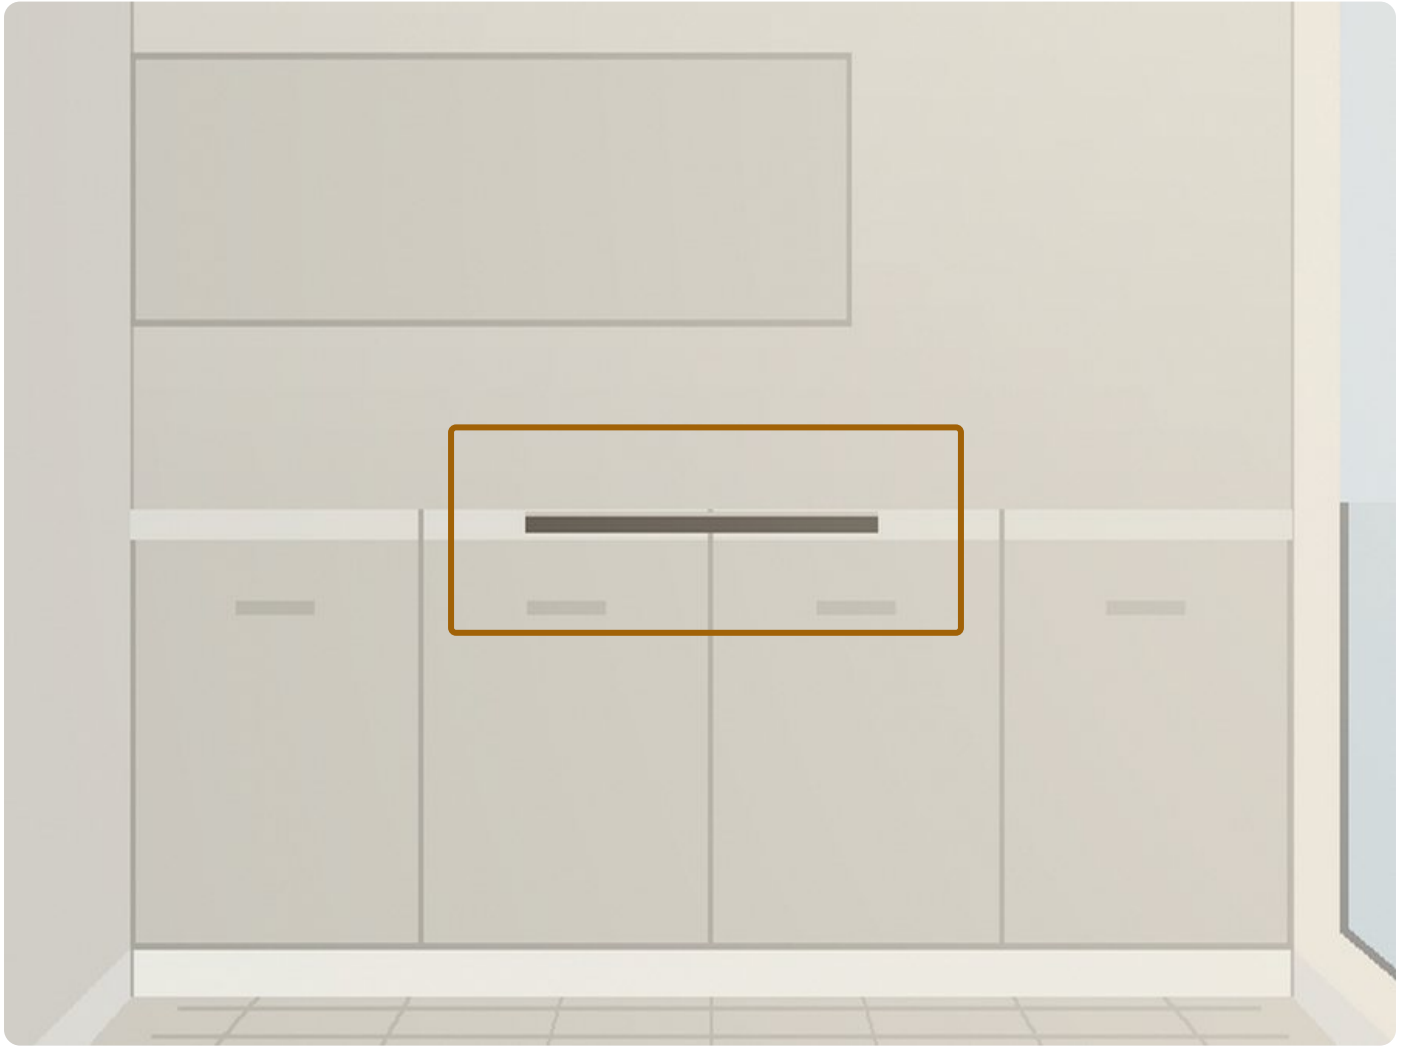
Kitchen

## Sealant gap at worktop junction

MINOR

The silicone bead between the worktop and the splashback has pulled away leaving an open joint, which will admit water behind the units.

**Recommended action:** Strip the failed bead, clean and prime the joint, re-apply a continuous mould-resistant sanitary sealant.
